# Manhole Inspection Summary

Manhole # S23K\_\_032MH

Insp Date: **4/16/09 10:24 AM**

**Location** Address: **236 S STRICKER ST**

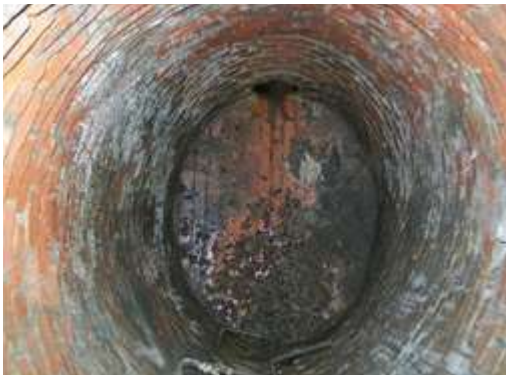
Defect 1

Infiltration: ☐ None ☐ Joint ☐ Cracks ☐ Mortar ☐ Roots ☒ Wall

Corbel Wall Infiltration

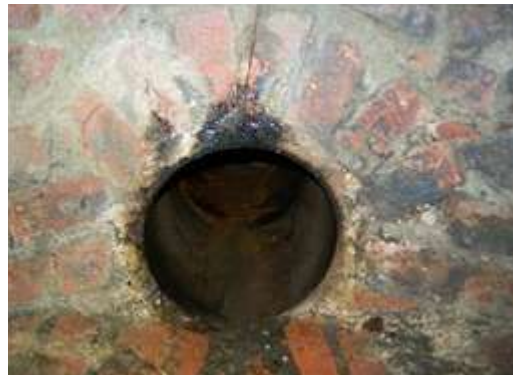
Defect 2

Condition: ☐ Sound ☒ Cracked ☐ Root Intrusion ☐ Loose Brick ☐ Deteriorated

Infiltration: ☐ None ☐ Joint ☒ Cracks ☐ Mortar ☐ Roots ☐ Wall

Crack and Infiltration in Barrel Wall above Pipe Out

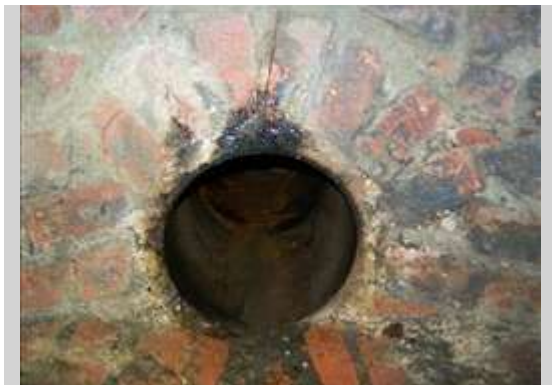
12 O'Clock Outflow

8 in. Circular Gravity Sewer  
Pipe Out @ 12 O'Clock

Infiltration: **Weeper** Pipe Seal Cond: **Sound**
